FINAL REPORT

AAIU Synoptic Report No: 2006-028

Aircraft Type and Registration:	B737-800, EI-DHX
No. and Type of Engines:	Two, CFM 56-7
Aircraft Serial Number:	33585
Year of Manufacture:	2005
Date and Time (UTC):	23 March 2006 @ 18.20 hrs
Location:	Ireland West Airport, Knock, Co. Mayo
Type of Flight:	Public Transport
Persons on Board:	Crew - 6 Passengers - 138
Injuries:	Crew - Nil Passengers - Nil
Nature of Damage:	None
Commander's Licence:	ATPL
Commander's Details:	Male, aged 39 years
Commander's Flying Experience:	7,998 hours (of which 295 were on type) Last 90 days – 261 hours Last 28 days – 62.27 hours Last 24 hours – 5.33 hours
Information Source:	AAIU Field Investigation

SYNOPSIS

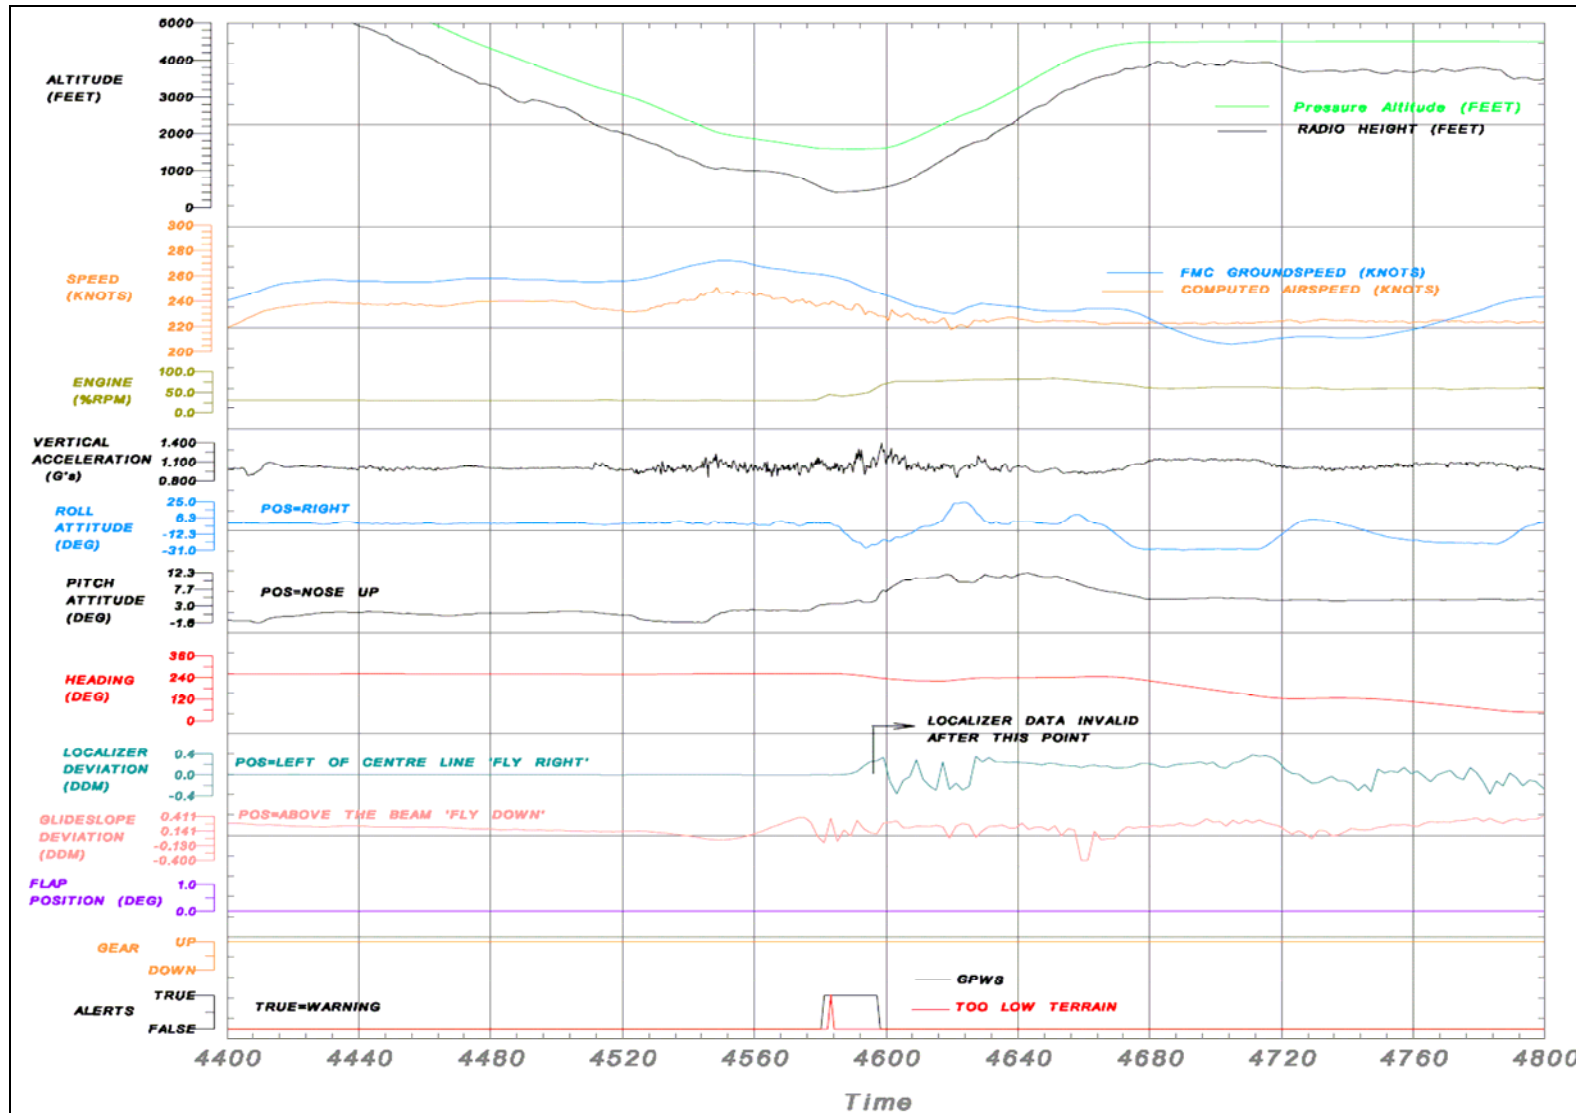
APPENDIX C

Information derived from the Operational Flight Data Monitoring (OFDM) System (**APPENDIX C**) showed that a high energy first approach was carried out to EIKN which contravened many of the Operators Standard Operating Procedures (SOP's), including the non deployment of flaps, landing gear, speed brakes, too high on glideslope (G/S) and culminating in an Enhanced Ground Proximity Warning System (EGPWS) Mode 4A alert, as the aircraft turned port in a Go-around (G/A) non-procedural manoeuvre. The System had triggered a, "*too low terrain*" alert. Mode 4A is active during the cruise and approach with gear and flaps up. It also provides alerting for protection against an unintentional gear up landing.
